May 2017 A Frame
5351 Chestnut Street
New Orleans, LA 70115

**Officers of New Orleans A's Chapter
Model A Ford Club of America**

Model A Hood Alignment

by Don Bowne Cambridge City, IN

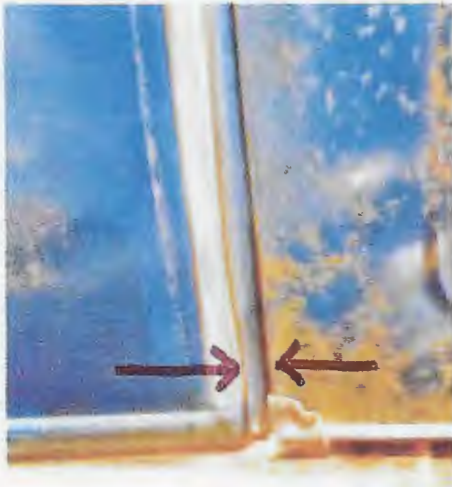
Above - This is where the hood does not fit properly; the gap is too wide due to a sagging bent frame.

When our Model A's were new everything fit properly, including the hood. However, after some 80 years of use and sometimes abuse many problems become evident. One of those is the alignment of the hood, especially the 1930 and 1931 cars. Most notably is the gap at the lower edge of the hood side panel where it meets the cowl. Also where this is the case the hood hooks do not align with the clips on the side panels. Another issue of this, is the radiator shell. This article will address this problem and show the procedure to correct it.

All of those blows combined have forced the front frame section up, thereby causing a slight bow in the frame rails. This, of course, accounts for the misalignment of the hood. The solution is to bring the frame rails back down thereby restoring the correct hood gaps.

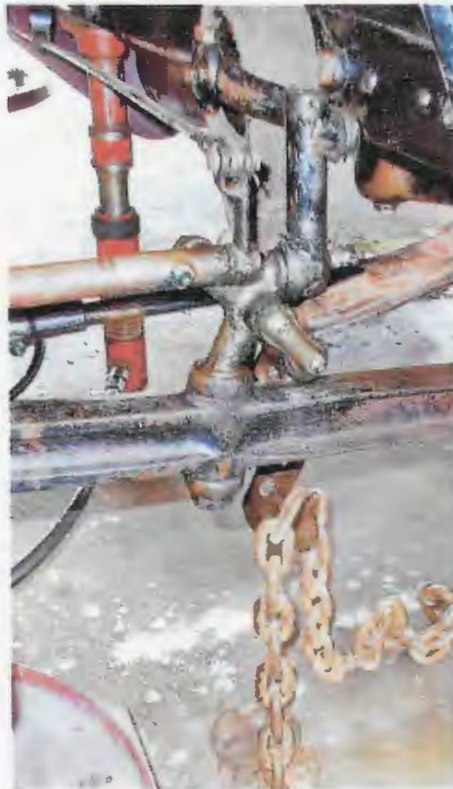
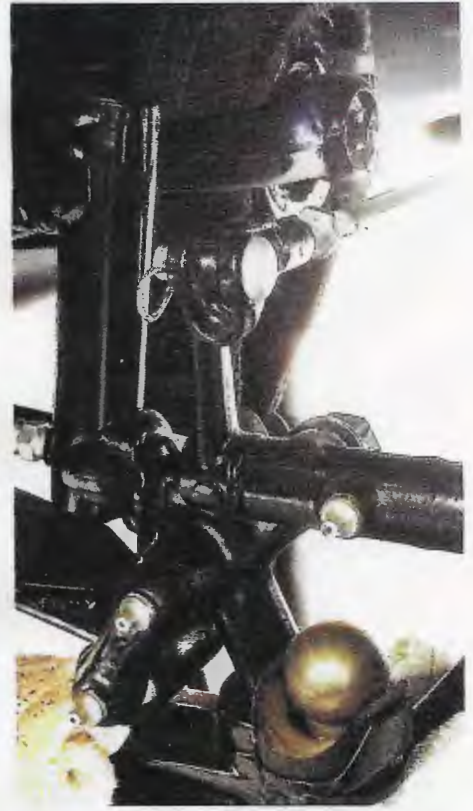
Photos at left and above. The frame is tied down in the front by a strap going over the shock and chained to the floor. I have a tie down anchor in the concrete floor for accomplishing this.

To do this, I tie the frame down at both ends and push up by placing a 10 ton jack directly under the car motor mount area as shown in the photos. I use a car tie down strap placed over the front shock body and over the rear bumper attaching arm. I have tie down anchors in my shop floor for this purpose, this is not a do it yourself procedure and is best left to for an experienced body and fender man. Otherwise one could be hurt and or further damage could be done to your car. I then use a porta power to push the frame upward and back into the original position. Please realize I must go past the original point to get the frame to end up flat once again. So the hood will go past the Cowl band in some cases in order to accomplish this task.

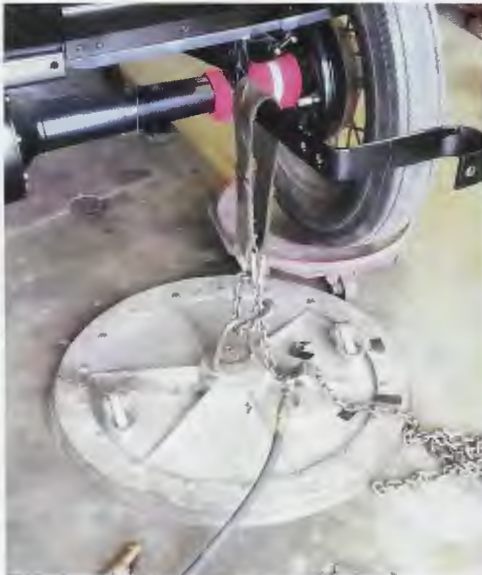
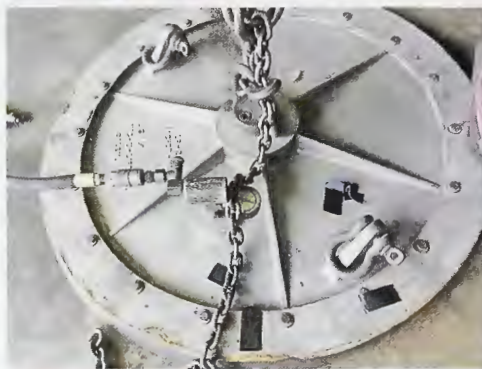
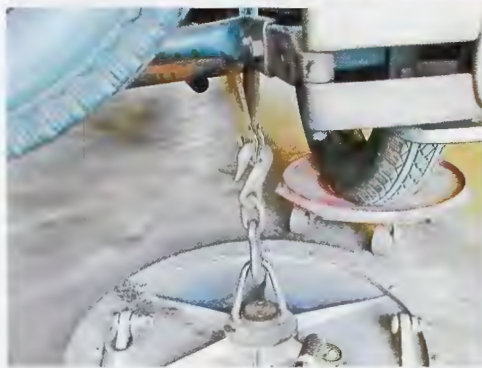
Above - In the rear I use a suction machine to grab the floor. This operates on compressed air. A Chain and strap are used to grab the car in the rear bumper brace area.

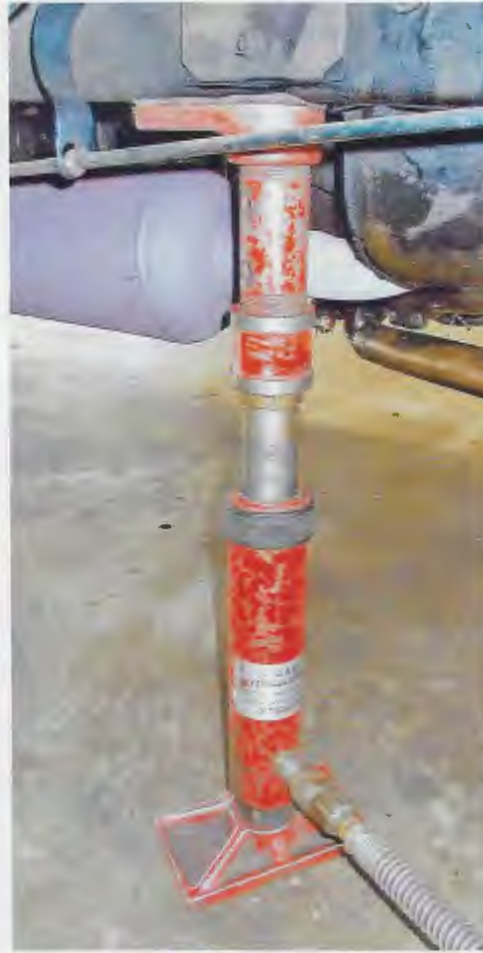
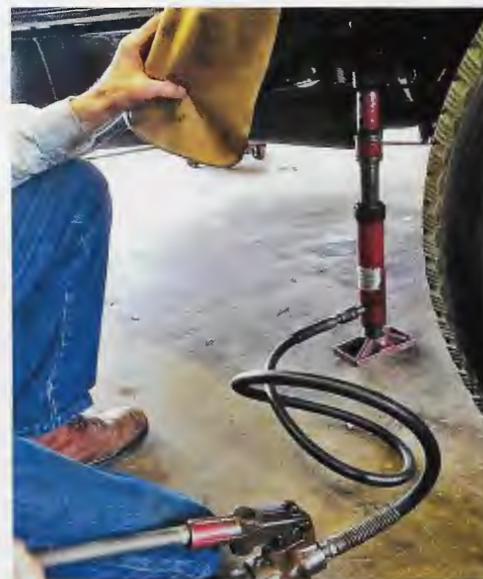
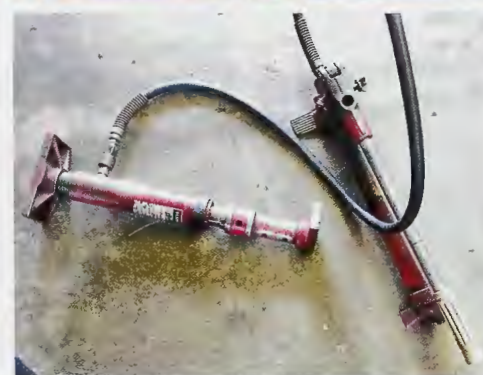
A Hydraulic Power unit is used to push the frame back into position.

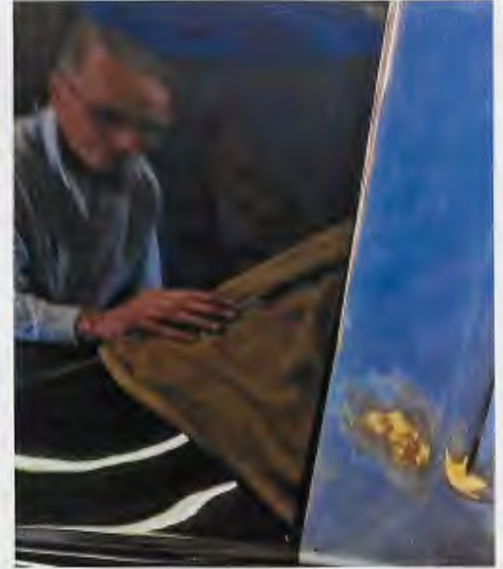
I have to go past the point in order to get it straight again.

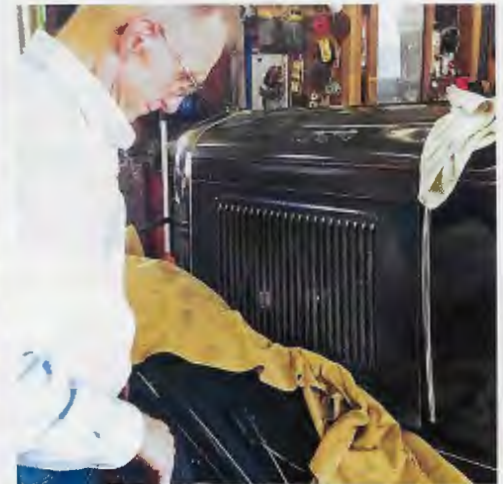
When it starts to get straight the alignment on the hood line will be very evident.

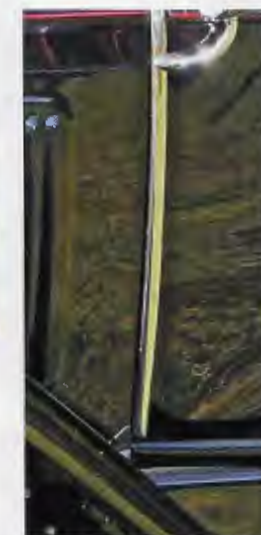
The end results will not only make the hood fit better but you will notice the gas, brake, and clutch pedals will align much better. The choke rod will work better without binding. Even the steering column will fit better.
